MEETING DETAILS			
Meeting Title:	Tweed Sand Bypass Advisory Committee (AC)		
Meeting No.:	04-2022		
Date / Time:	5:00pm (Qld) 16 November 2022		
Location:	Kirra Hill Community Centre		
Attendees:	Kane Nielsen – A/QLD AC Member Anthony Johansson – NSW AC Member Adrian Barwick – NSW AC Member John Ede – NSW AC Member Wayne Bartholomew – Qld AC member Peter Turner – Qld AC Member Kim Bowra Bruce Harper Bruce Lee		
Absent / Apologies:	Apologies: Jane Lofthouse – NSW AC Member Councillor Gail O'Neill – QLD AC Member		
Minutes Prepared By:	A. Barwick		
WBS:	M.07

ADVISORY COMMITTEE MEETING

16 November 2022

PROJECT MONITORING AND OPERATIONAL OVERVIEW

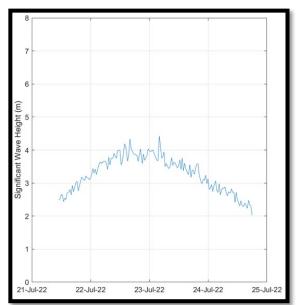
ANALYSIS OF LOVERS ROCK PLACEMENT DURING LARGE SWELL

21.07.22 to 25.07.22 = 11,445 m3 pumped to lovers with missed day on 24th due to slurry pump issue

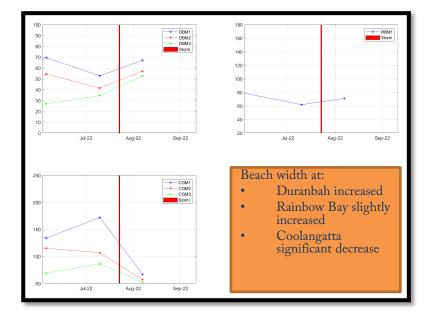
15,517 m3 pumped to SRE + 11,445 m3 pumped to lovers between 15 Jul and 10 Aug

15th July 2022

25th July 2022

10th August 2022

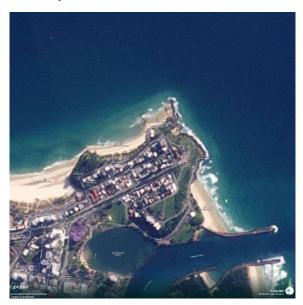
41,230 m3 pumped to SRE between 9 Oct 2018 and 14 Nov 2018

9th Oct 2018 23rd Oct 2018 14th Nov 2018

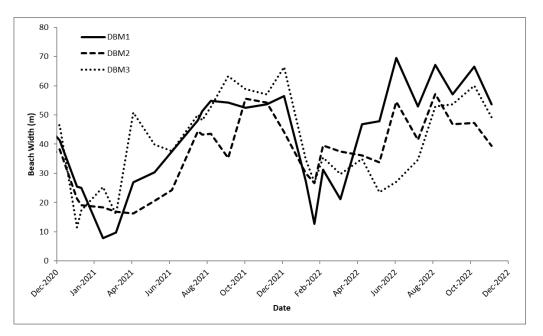
DURANBAH - BEACH WIDTH DATA

500 400 DBM2 DBM3 300 ш 200 100 -100-200 -300 -500 m

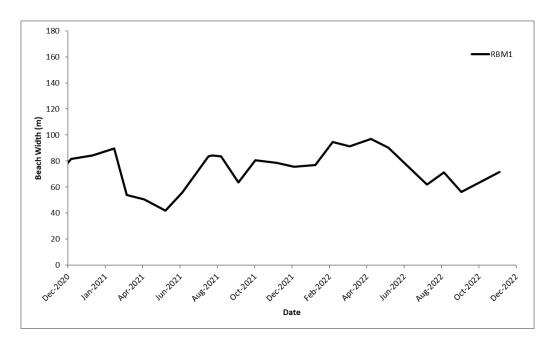
RAINBOW BAY - BEACH WIDTH DATA

0 -100 m

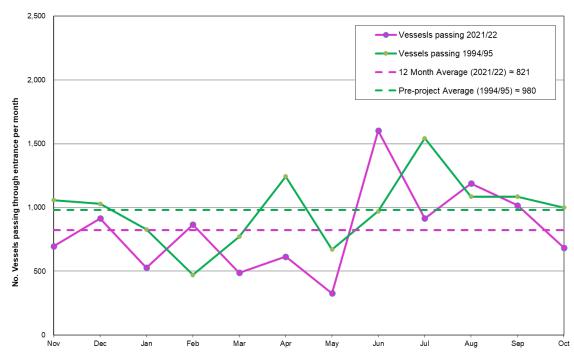
- Generally vessel passing numbers have been variable and highly dependant on conditions.
- On average over the past 12 months numbers have been just under the pre-project average.

Comparison of vessels passing through the entrance per month in 2021/22 compared to 1994/95 (prior to entrance improvements)

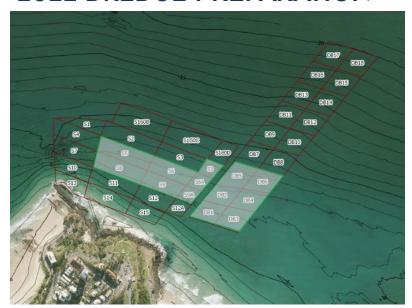
33,174m3 placed at Snapper Rocks and 30,599m3 placed at Duranbah

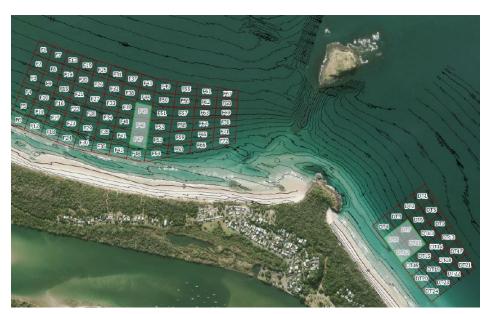
8,626m3 placed at Dreamtime
