# Tweed Sand Bypassing

## Environmental Monitoring Report

Project: Tweed River Entrance Sand Bypassing Project

Report No. CA – 25

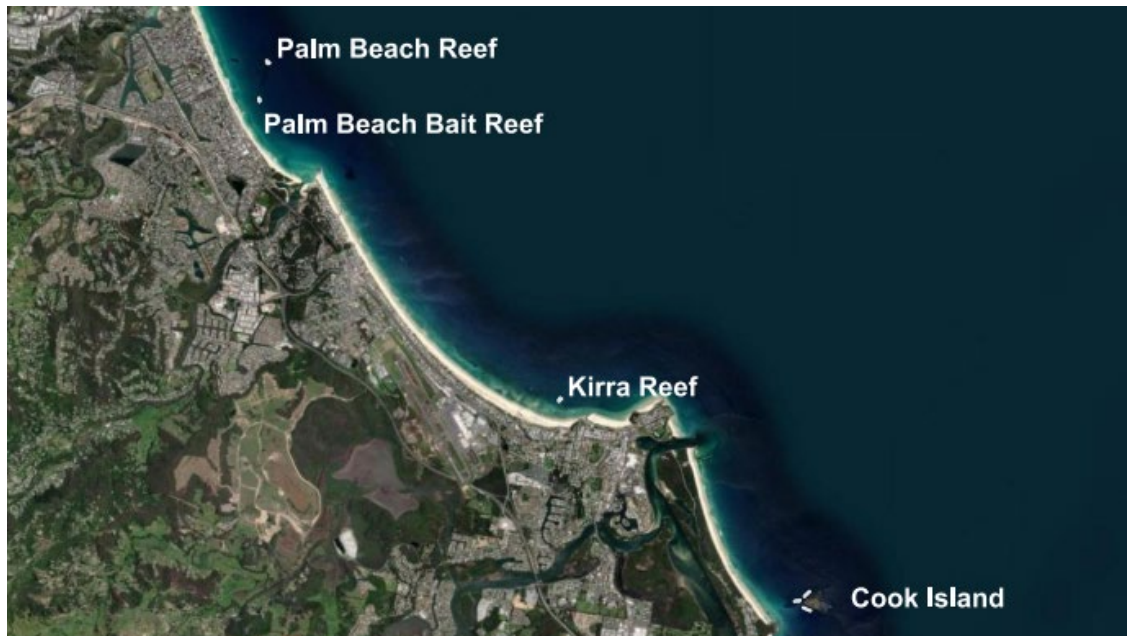
**Figure 1** Reef monitoring locations (Ecological Service Professionals Pty Ltd)

Six reef locations are included in surveyed activities (refer [Figure 1](#)): Kirra Reef (previously impacted reef, as assessed under the EIS/ IAS); Cook Island West and South Reefs (potential impact reefs, as assessed under an REF for back-passing by dredge); and Cook Island North Reef, Palm Beach Bait Reef, and Palm Beach Reef (comparative reefs). Historically monitoring has occurred in May to June, however it was recommended to move this date forward to July in favour of expected

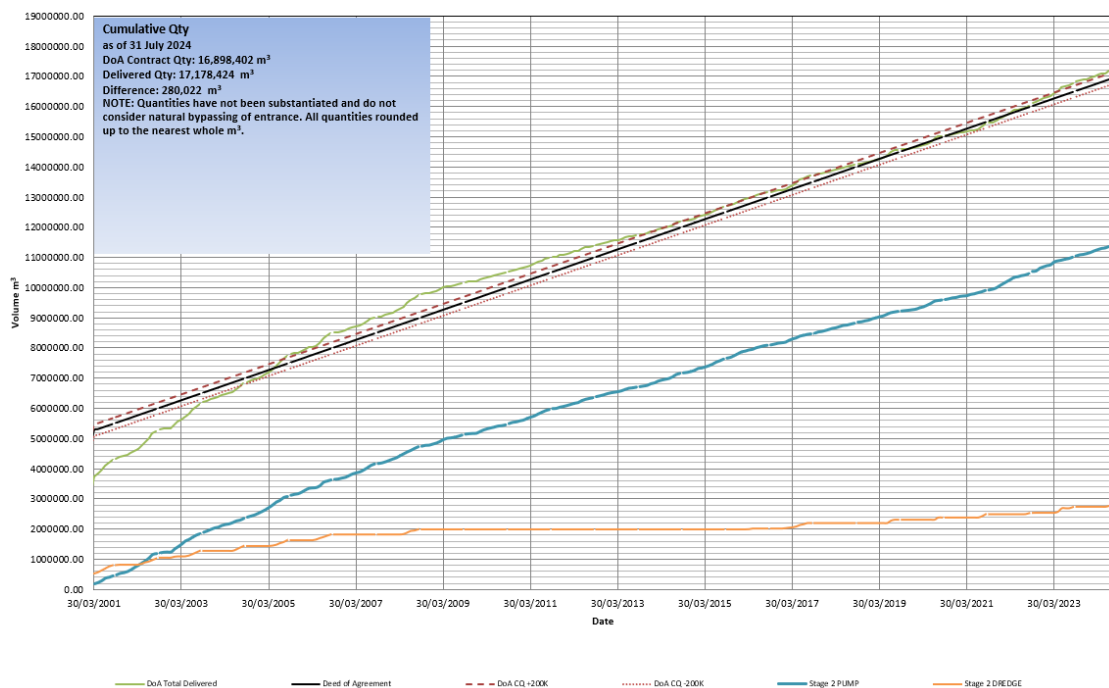
**Figure 14** Comparison of CQ, DoA and DoA sand delivered

Back-passing impacts on longshore sediment transport are also monitored through tracking the Contract Quantity (CQ). CQ is defined in the Deed of Agreement (DoA) and can be summarised as, the cumulative quantity of sand which is to be delivered over time as per relevant calculations and clauses in the DoA or as otherwise agreed in writing by the Governments. The Long-Term Average (LTA) is a key metric used when forecasting CQ, with LTA being reassessed every 5 years. As of July 2024, the difference between total sand delivery and CQ was approximately 280,022 m<sup>3</sup>.

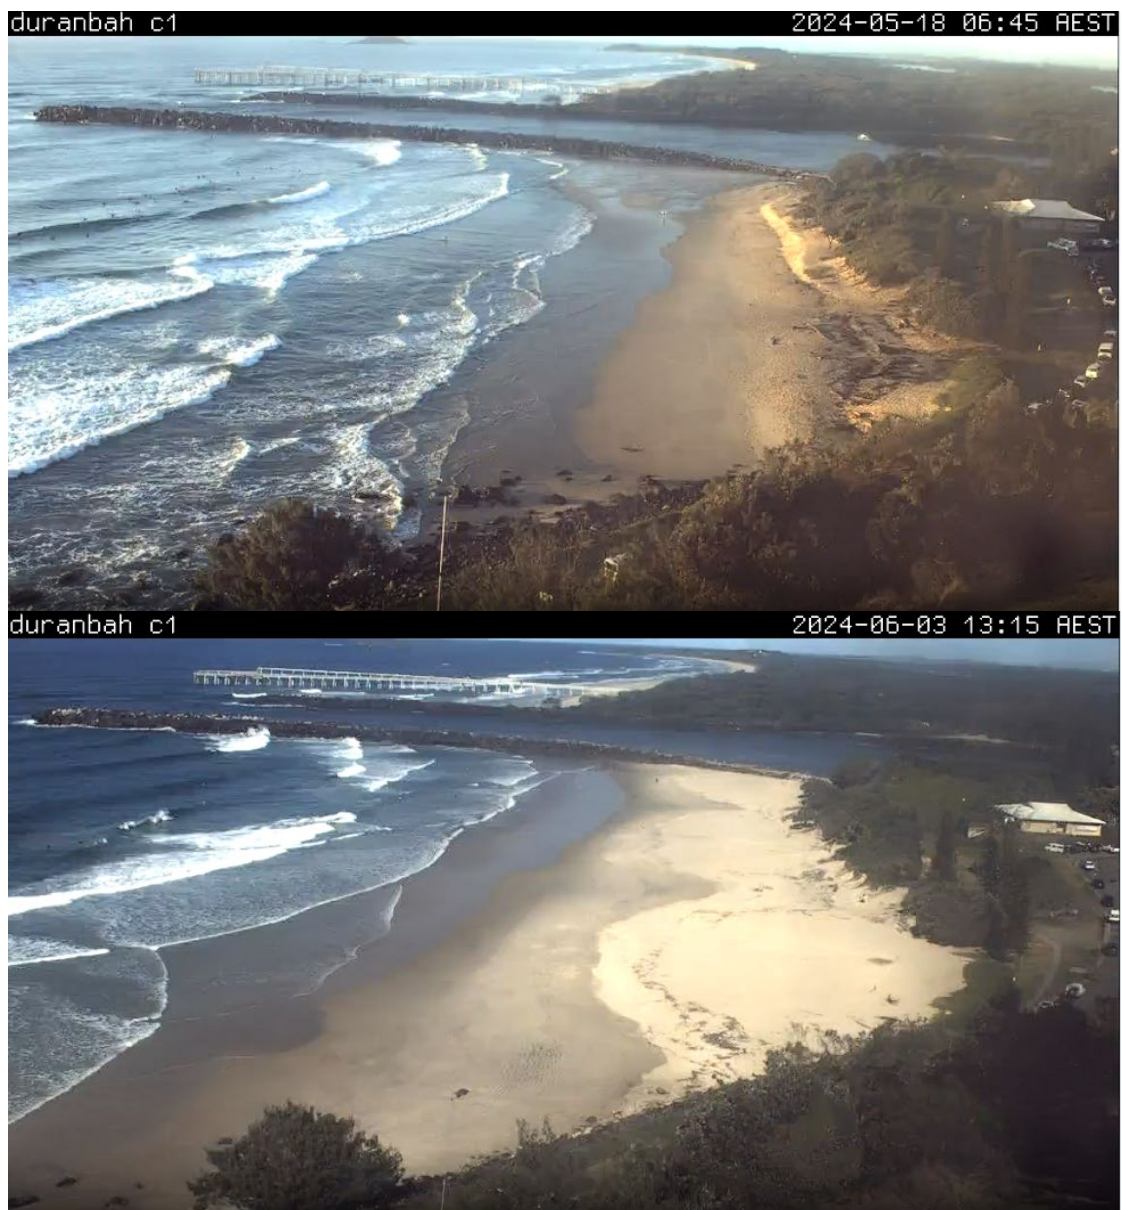
**Figure 18** Duranbah pre-nourishment (top), and post-nourishment (bottom)

March 2024 had a consistent strong E swell direction coupled with significant wave heights. The conditions affected the upper beach at Duranbah, with scarping observed off the southern corner and Tyalgum wreck and the rocky outcrops in the swash zone exposed briefly. Periods of calmer conditions throughout April allowed some level of beach building to occur, although the sediment transport rate was less than the April average.

The surf amenity at Duranbah was maintained throughout the sand nourishment campaign.

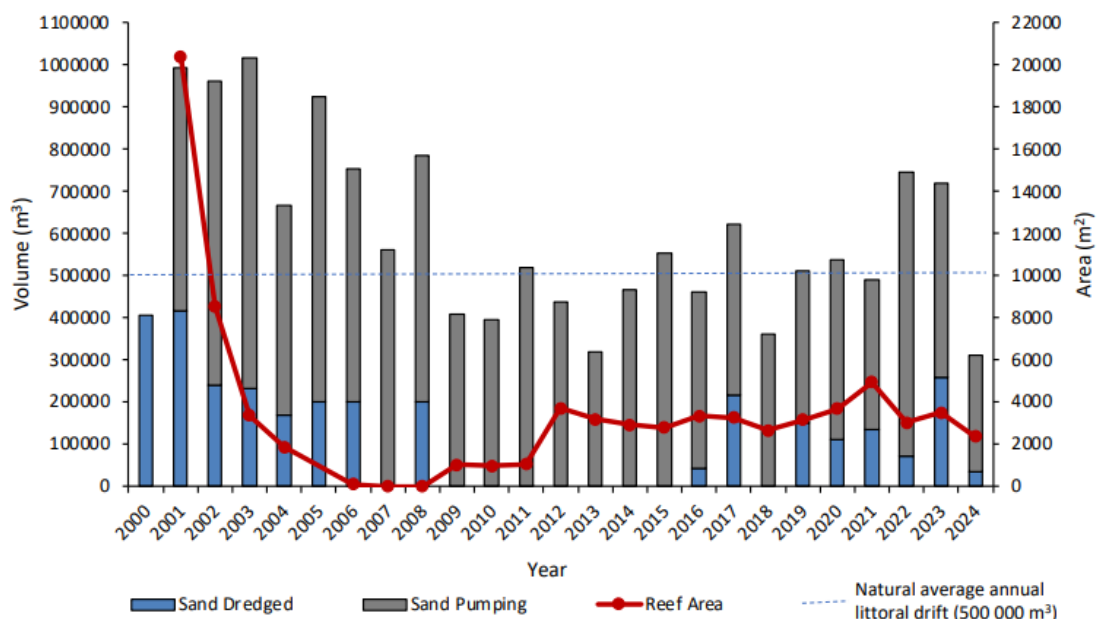
**Figure 22** Estimated surface area (m<sup>2</sup>) at Kirra Reef and total annual dredging and pumping volumes (m<sup>3</sup>) between 2000 and 2024 (data for 2024 includes sand volumes up to end of July) (Source: Reef Biota Monitoring 2024, ESP).

Monitoring reports from the earlier stages of the project show there were substantial changes in the aerial extent of Kirra Reef through time, with the maximum extent measured in 1995 (approx. 5900m<sup>2</sup> in northern section), declining to its lowest extent in 2008, then increasing again from 2010 and remaining relatively stable since 2012, refer Figure 22 below.

The areal extent of Kirra Reef decreased over the past year from 3,492 m<sup>2</sup> in April 2023 to 2,365 m<sup>2</sup> in June 2024; however, remains within the relatively stable reef extent observed since 2012. This change in reef area was likely due to an offshore sandbar, as TSB pumping operations were consistent over the last year (Ecological Service Professionals (ESP), 2024).

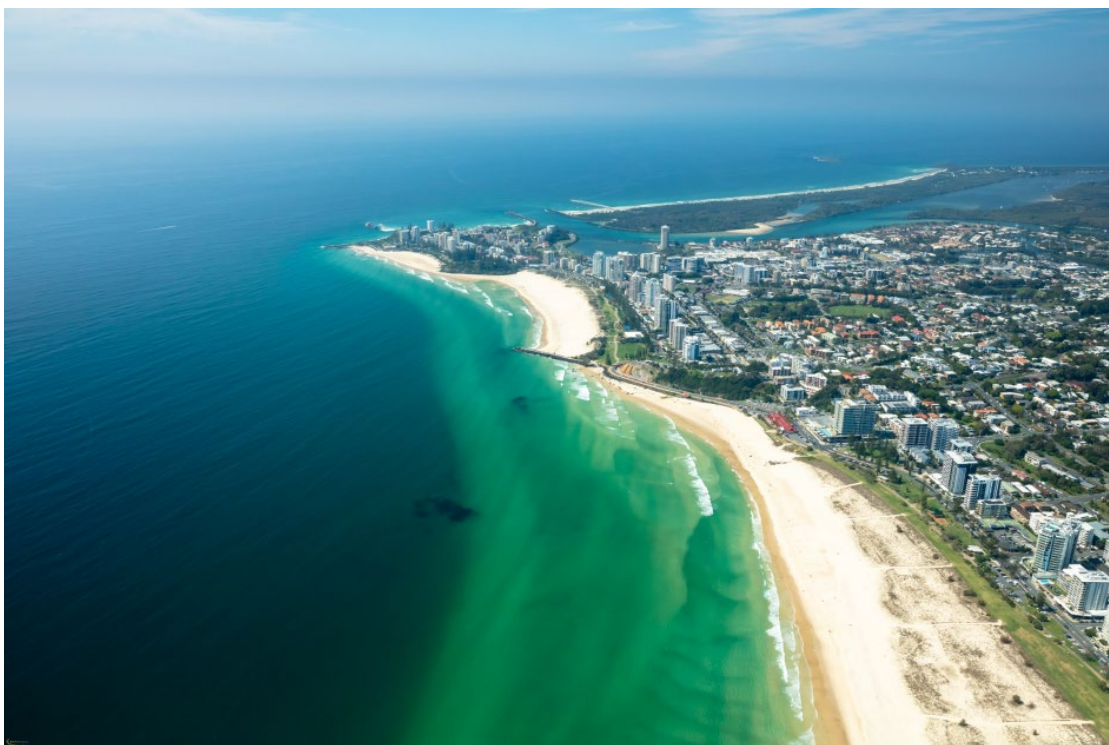
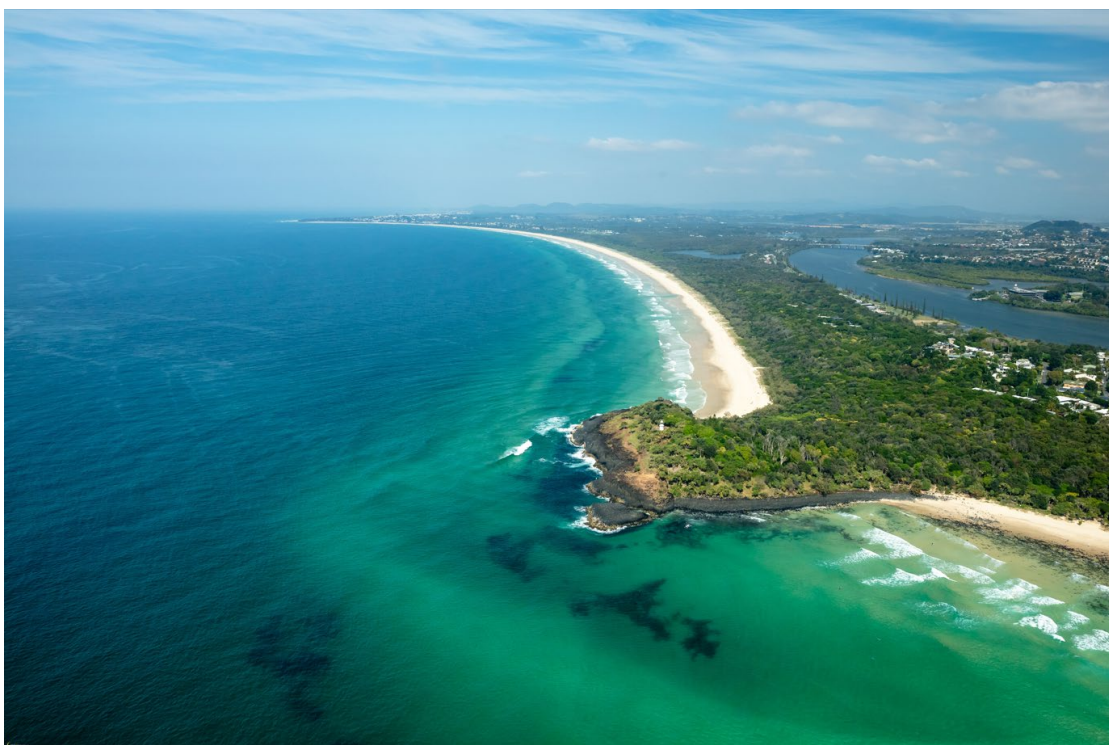
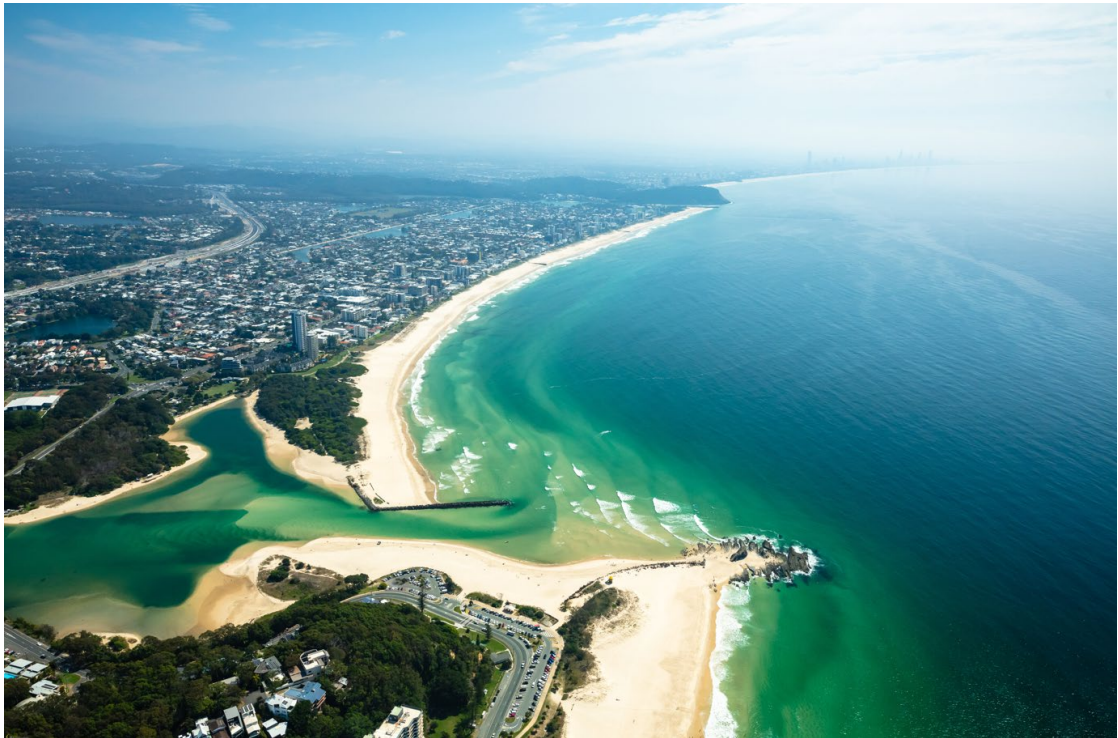
The offshore sandbar can be clearly seen in oblique imagery captured in August 2024 (Figure 23 to Figure 25), with extents of this sandbar extending south past Fingal head and north of Currumbin. Well outside the boundaries of operational influence by dredging or pumping.

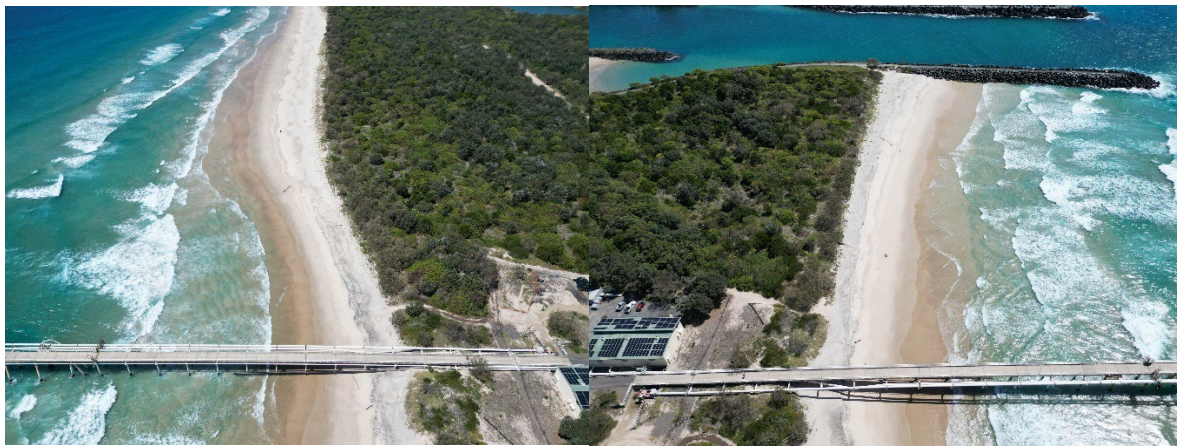
South – October 23

North - October 23

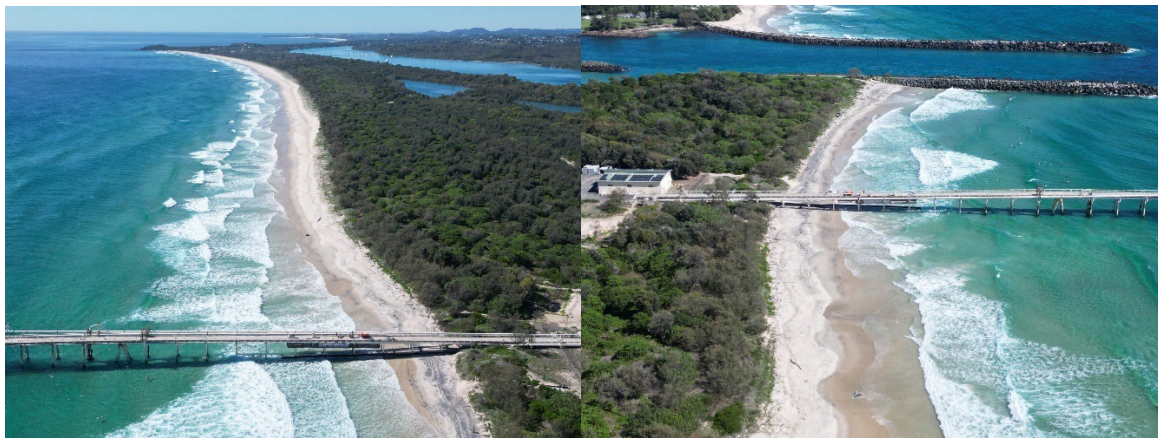
South – November 2023

North – November 2023

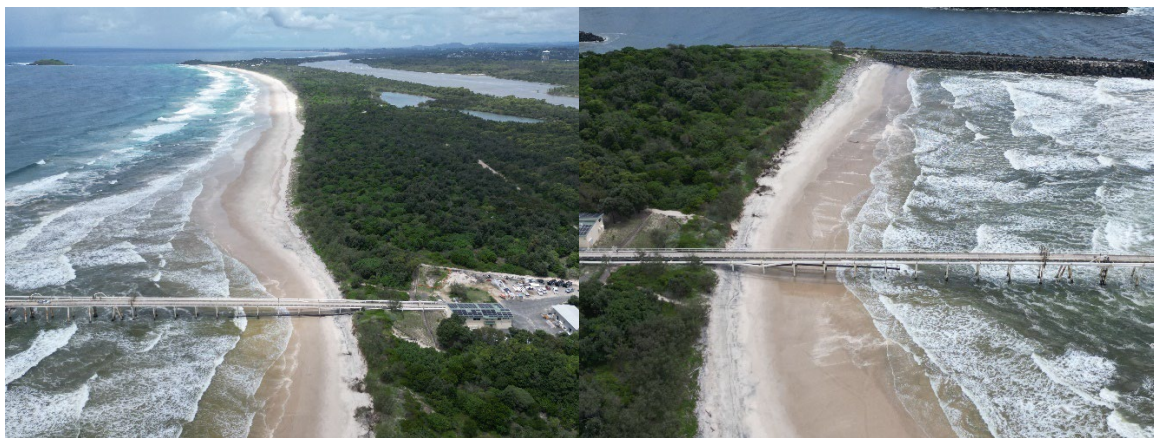
South – February 24

North – February 24

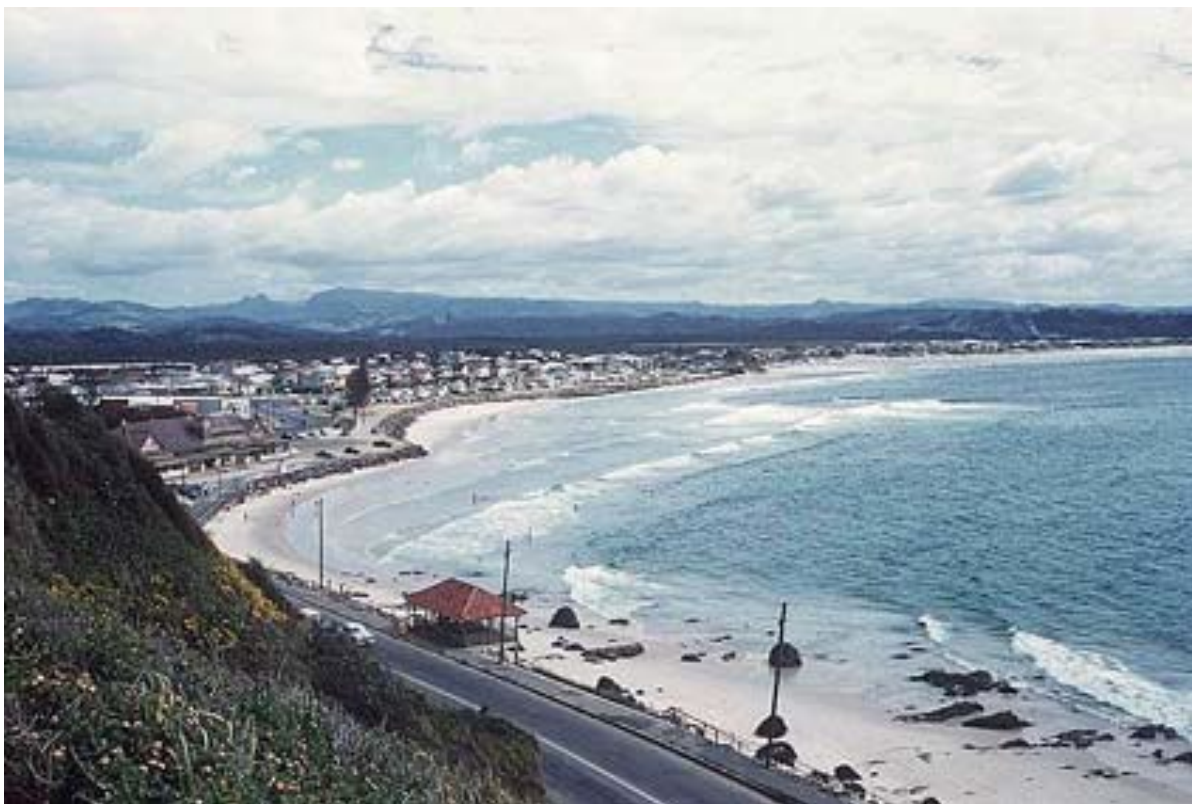
**Figure 2 Eroded Kirra Beach in the late 1960s.**

Due to the accumulation of sand on Letitia spit, there was very little sand available at the southern Gold Coast to replenish the beaches after storm activity. After two decades of stormy weather in the 1960s and 1970s, the beaches of the southern Gold Coast were severely eroded. The late 1970s to 1990s experienced fewer storm events, but erosion continued, as the sand supply that was able to replenish the beaches was still blocked by the training walls. This loss of sand impacted the protection of infrastructure, recreational activities, tourism and the local economy.

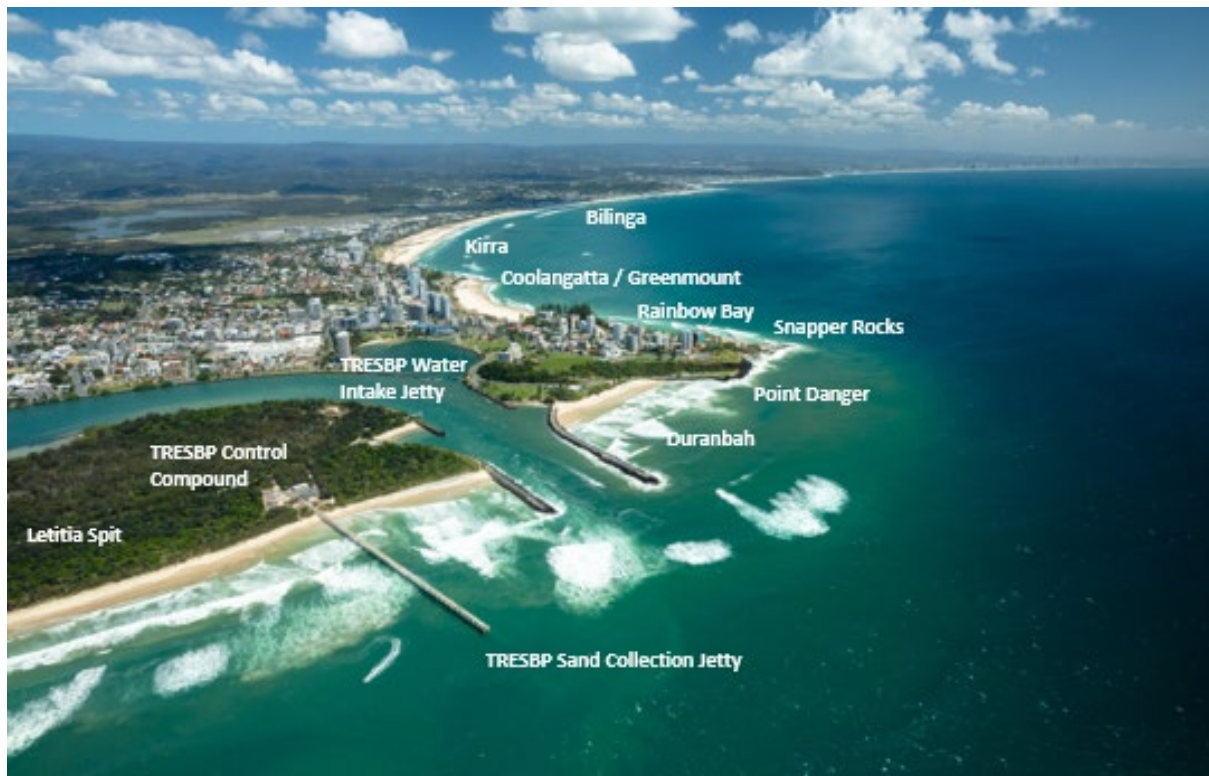
Figure 3 Aerial Photographs of Project Site, TSB system and locality (photo: October 2022)

The JMPS has an overall length of 450 metres constructed perpendicular to the Letitia Spit beach. The jetty supports 10 submersible jet pumps that sit below the seabed and collect the sand that is naturally transported towards them. The collected sand is then transported via an underground pipeline network to a chosen sand delivery outlet.

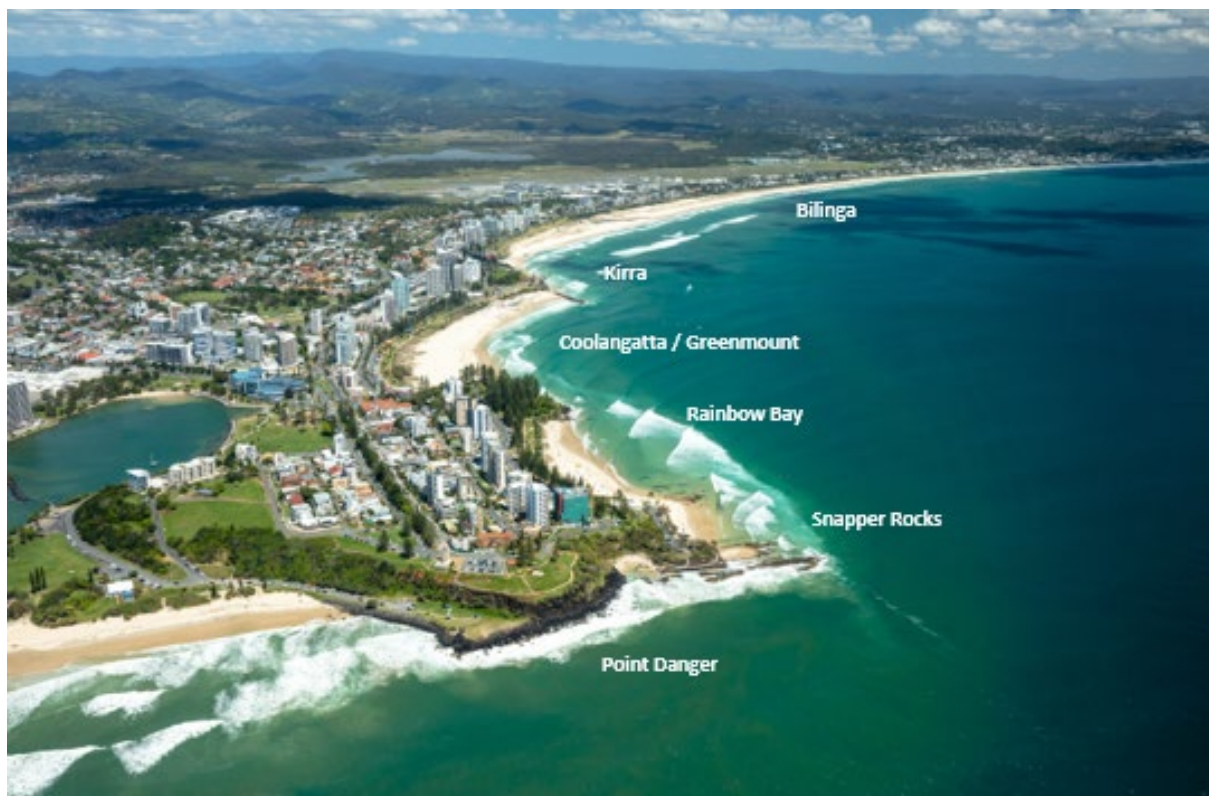
Figure 4 Aerial Photographs of Project Site, southern Gold Coast beaches (photo: October 2022)

- A sand collection jetty, pumps and control building at the northern end of Letitia Spit, about 250 m south of the southern Tweed River breakwater (refer to Figure 1).
- A clean water low pressure pump station mounted on a short jetty (intake Jetty) on the southern river training wall at the northern end of Letitia Spit (refer to Figure 1).
- A compound area at the landward end of the sand collection jetty for the housing of a control building and workshop, and sand slurry collection pit (refer to Figures 1 & 3).
- A sand delivery pipeline that crosses under the Tweed River about 250 m downstream of Jack Evans Boat harbour (refer to Figure 3 & 4).
- Sand delivery outlets at Snapper Rocks East, Snapper Rocks West, Duranbah, Greenmount and Kirra Point (refer Figure 4).

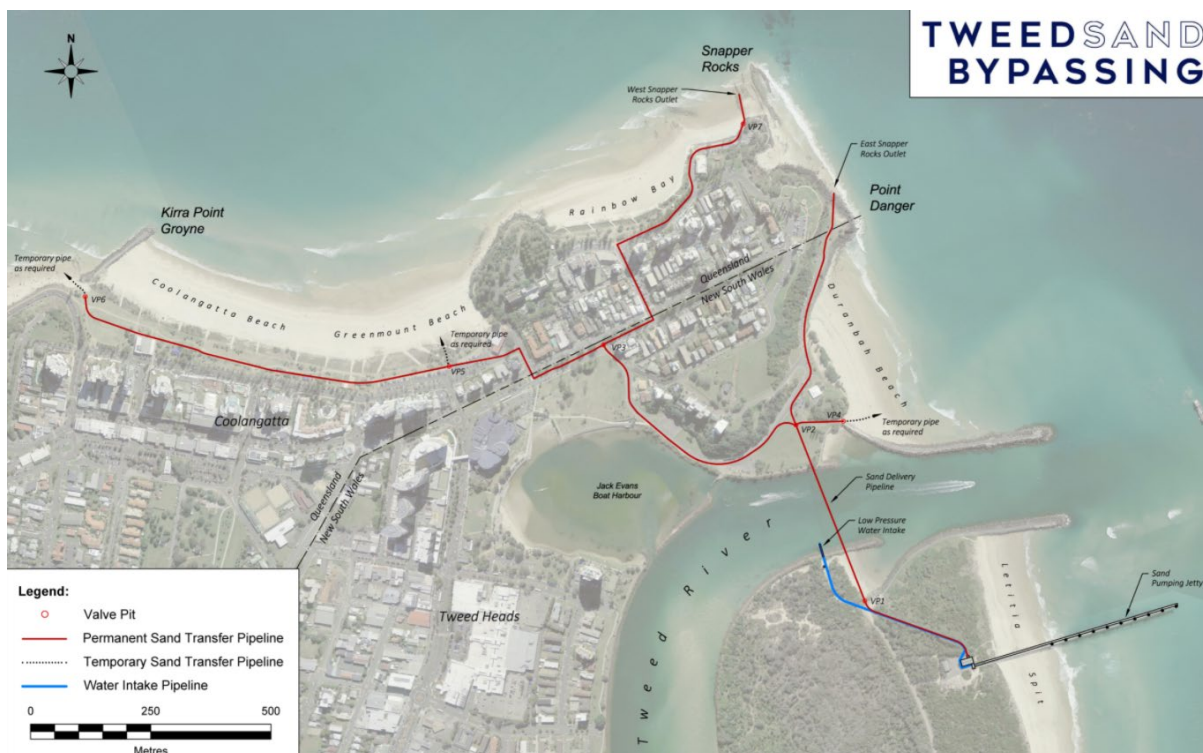
Figure 6 Location of TSB pumping outlets (TRESBP)

Nearshore placement zones from Dreamtime to Bilinga Beach have been established for the deposition of dredged sand (refer Figure 6). Typically, a volume of up to 200,000m<sup>3</sup> per dredge campaign is placed within these zones.
